CRUISE CONTROL SYSTEM

1983 Mazda RX7

1983 CRUISE CONTROL SYSTEMS

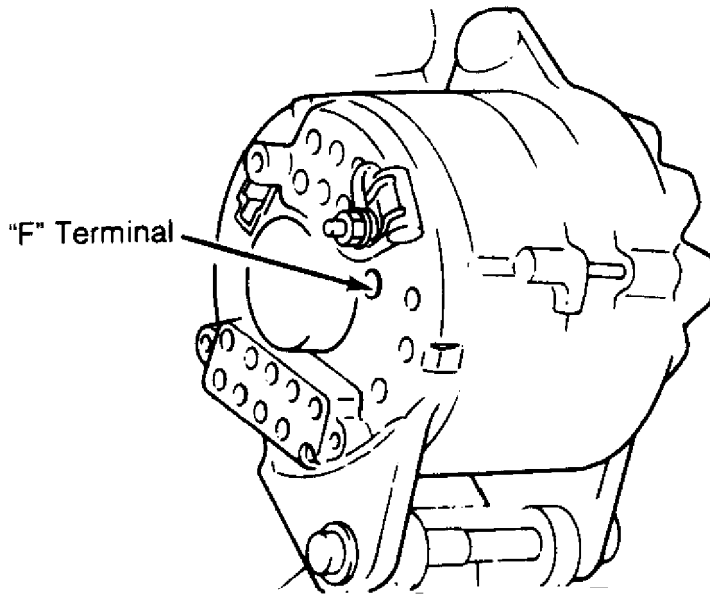
29386

Fig. 1: Alternator "F" Terminal Location
Terminal is located .8" (20 mm) below the hole.

4) Read the voltage at "L" with "F" terminal shorted. If voltage is lower than battery voltage, regulator is defective. If voltage is close to battery voltage, alternator is defective.

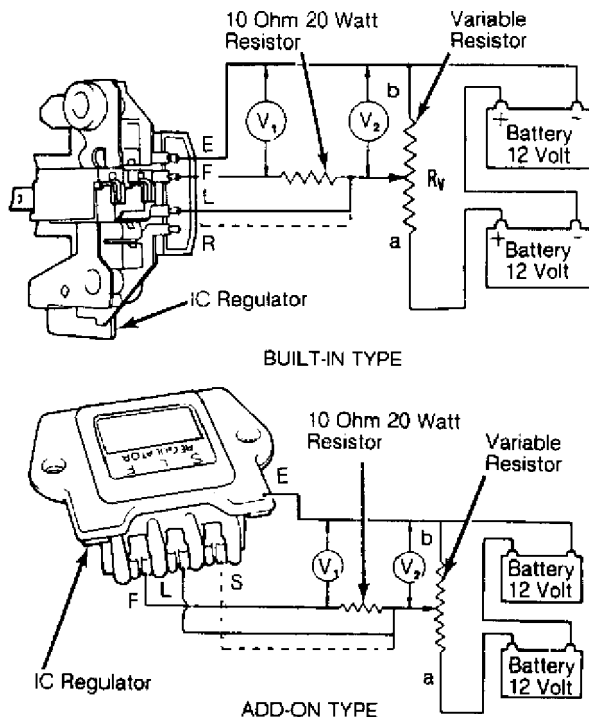
29388

Fig. 3: Testing Mitsubishi Integral Regulator

2) If diode shows small resistance in both directions, it is shorted. If large resistance is shown in both directions, diode is open. Heat sink and diodes are replaced as an assembly.

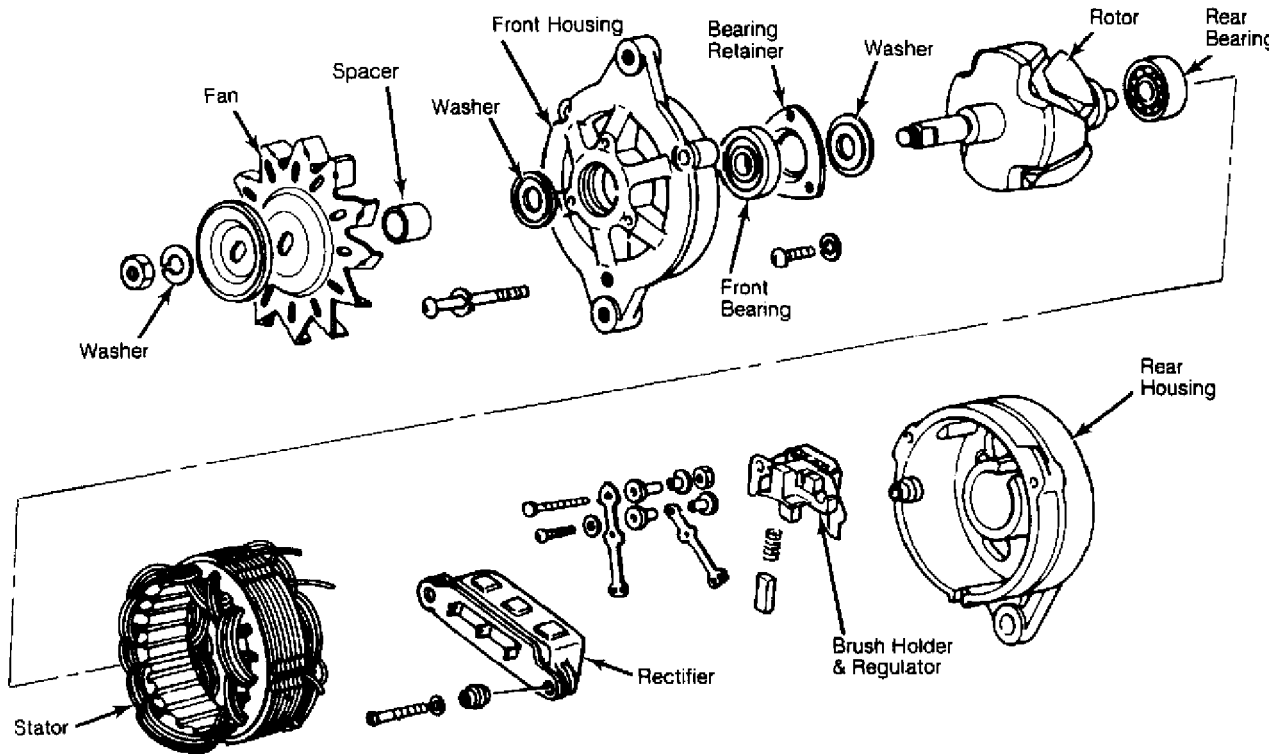
29389

Fig. 4: Exploded View of Mitsubishi Alternator

Reassemble by reversing disassembly procedures. Soldering of rectifier leads should be done in less than 5 seconds to prevent damage to diodes. When installing the rotor assembly in the rear housing, hold the brushes in position by inserting a stiff piece of wire into the access hole in rear housing.

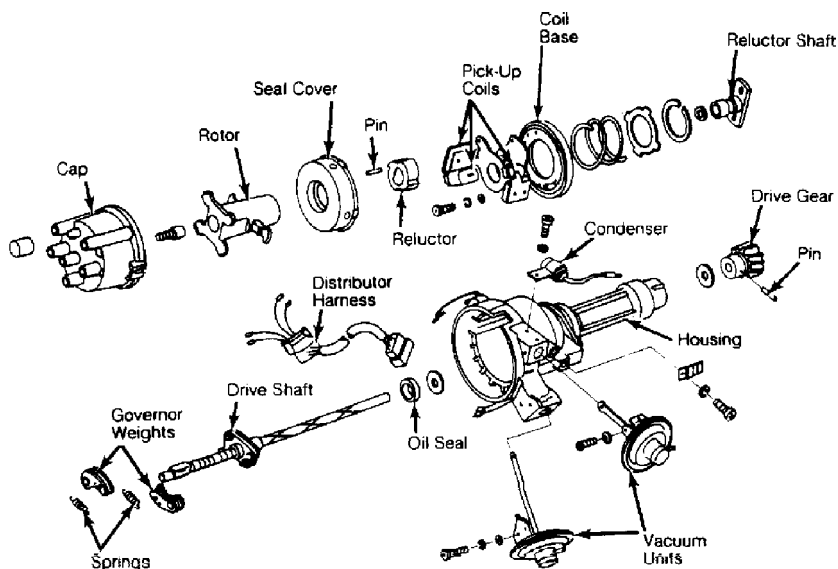
29017

Fig. 6: Disassembled View of RX7 Mitsubishi Distributor

2) Assemble distributor in reverse order of disassembly, noting the following: Install reluctor shaft onto distributor drive shaft, engaging slots of reluctor shaft and governor pins. Install pick-up coil and coil base bearing assembly and tighten attaching screws. Install reluctor on shaft, driving spring pin in with a punch.

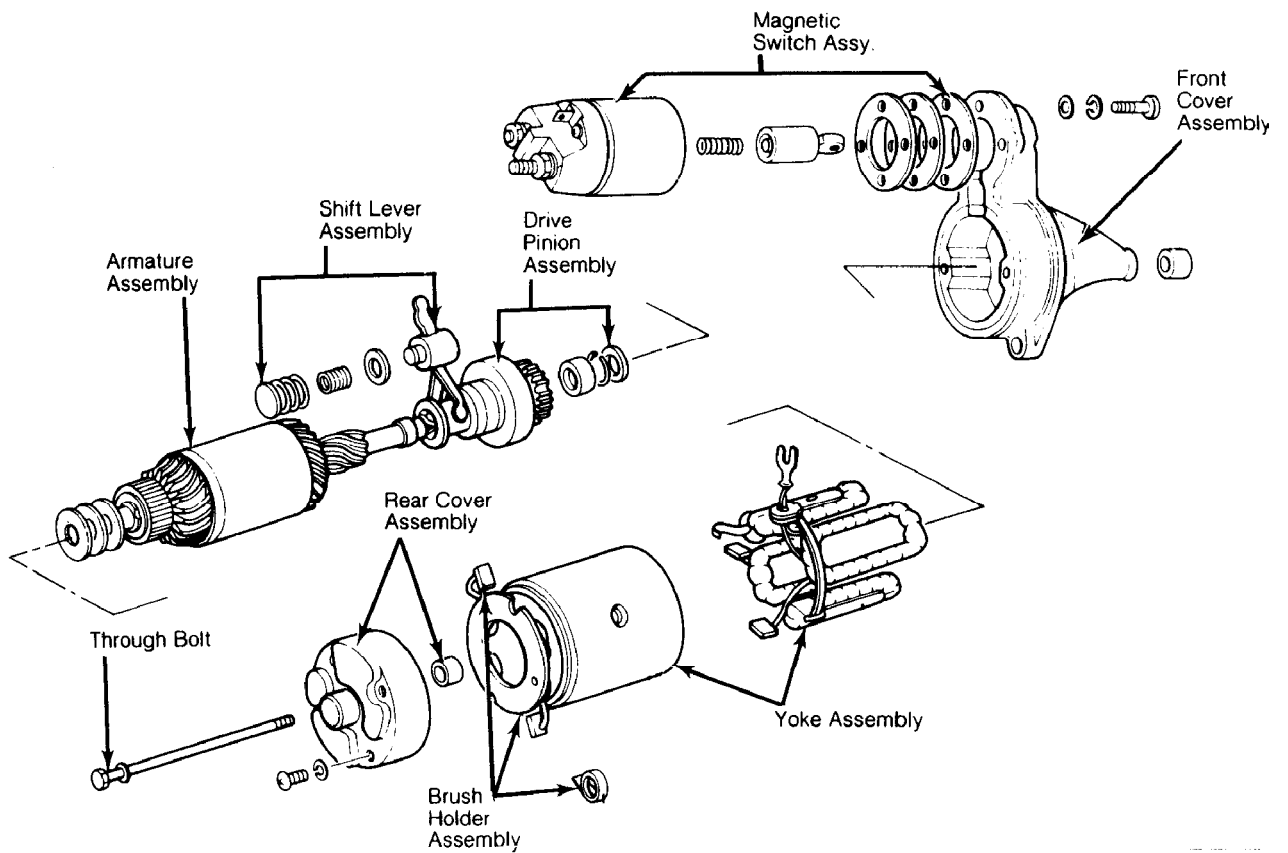
29420
Fig. 5: Disassembled View of Typical Mitsubishi Conventional Starter

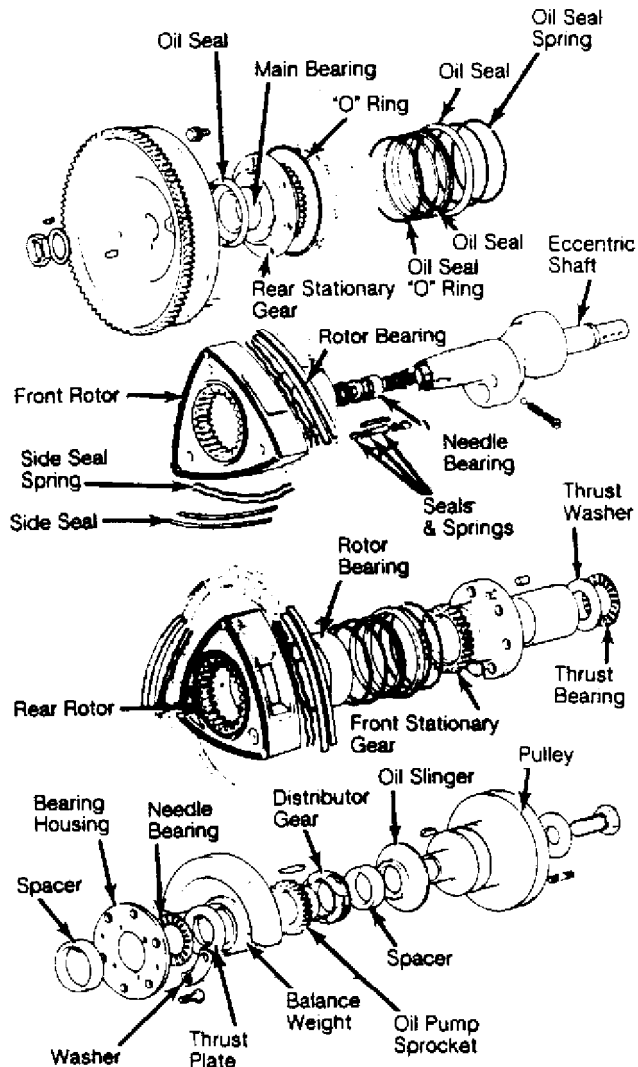
Fig. 1: Exploded View of Rotors & Eccentric Shaft Assembly

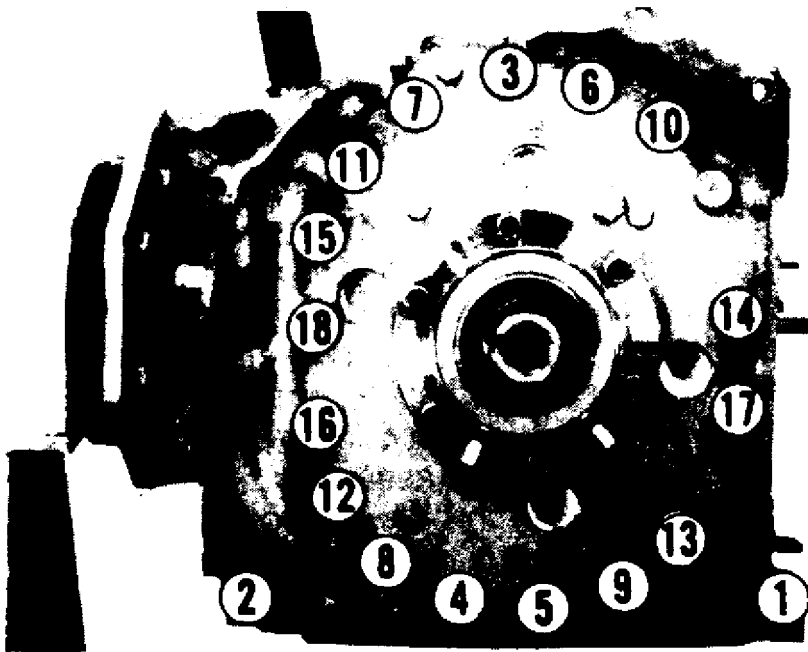
Fig. 3: Loosening Sequence of Tension Bolts
Loosen in 2 or 3 steps.

7) Remove tension bolts on rear housing in sequence. See Fig. 3. Loosen in 2 or 3 steps. Lift rear housing off shaft. Remove any seals stuck to rotor sliding surface, and place them back in original positions. Remove seals and "O" rings from face of rear rotor housing.

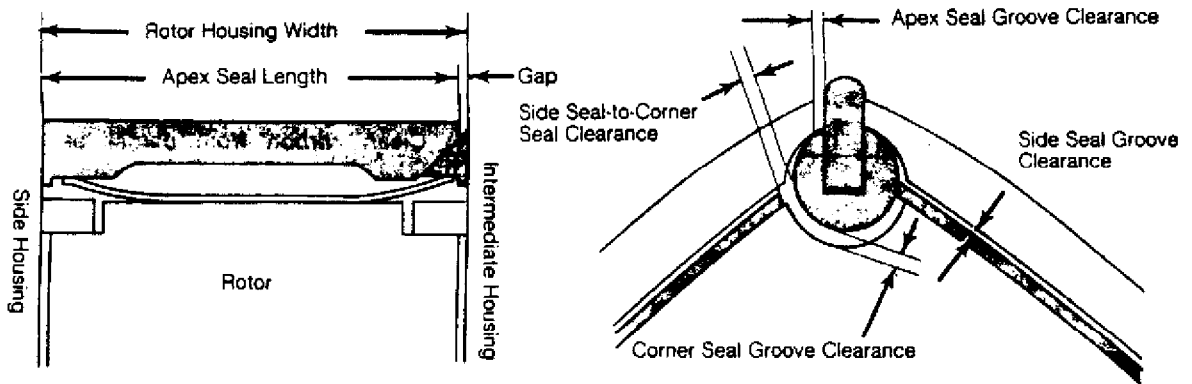
Fig. 18: Measuring Clearance of Apex, Side & Corner Seals

3) If neither end of gauge goes into groove, it indicates that gap conforms to specifications. If "Go" end of gauge goes into groove, it indicates that gap is more than standard, but less than wear limit. In this case replace corner seal. See Fig. 18.

4) If both ends of gauge (both the "Go" and "No Go" ends) fit in groove, it indicates that gap exceeds wear limit. Replace rotor.

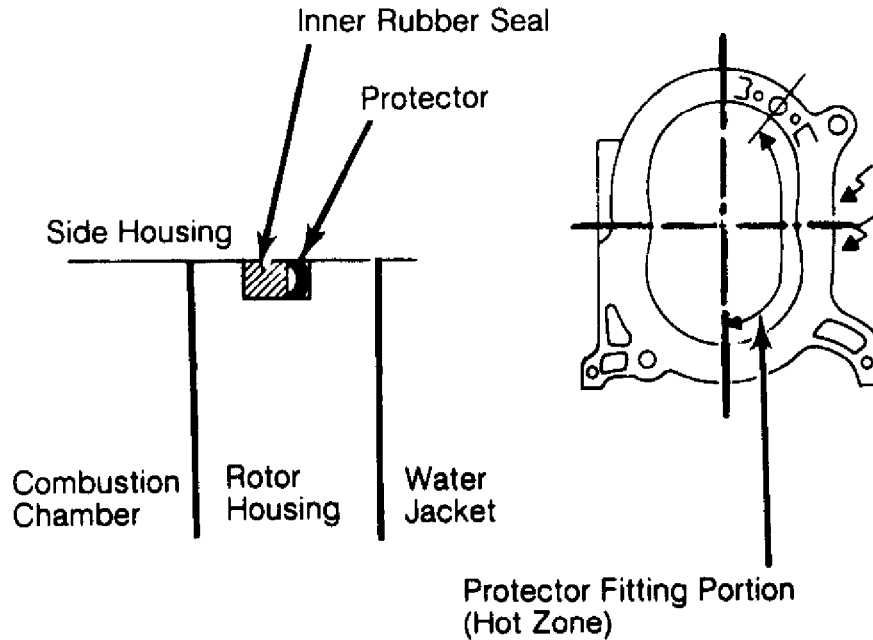
Fig. 23: Installing Protectors for Inner Sealing Rubbers
Apply light coat of petroleum jelly to hold seals in place.

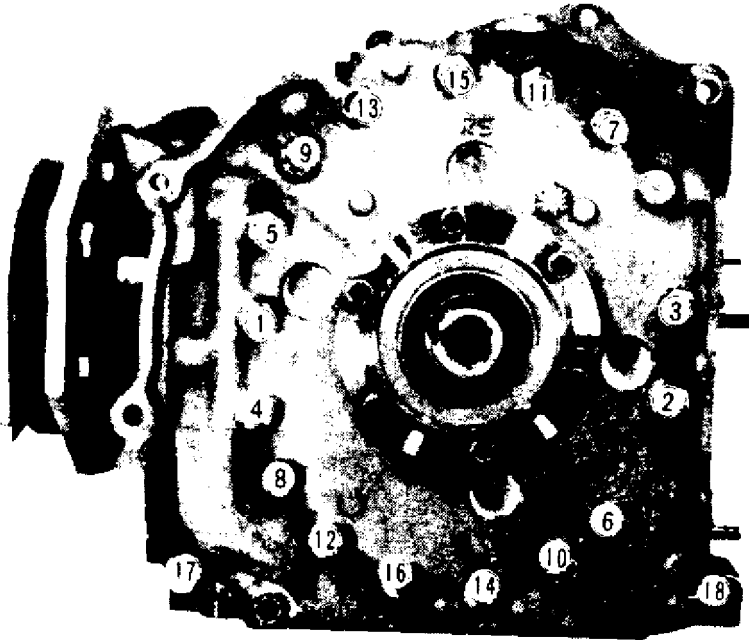
Fig. 26: Tightening Sequence of Tension Bolts
Replace all tension bolt sealing washers when the engine is overhauled.

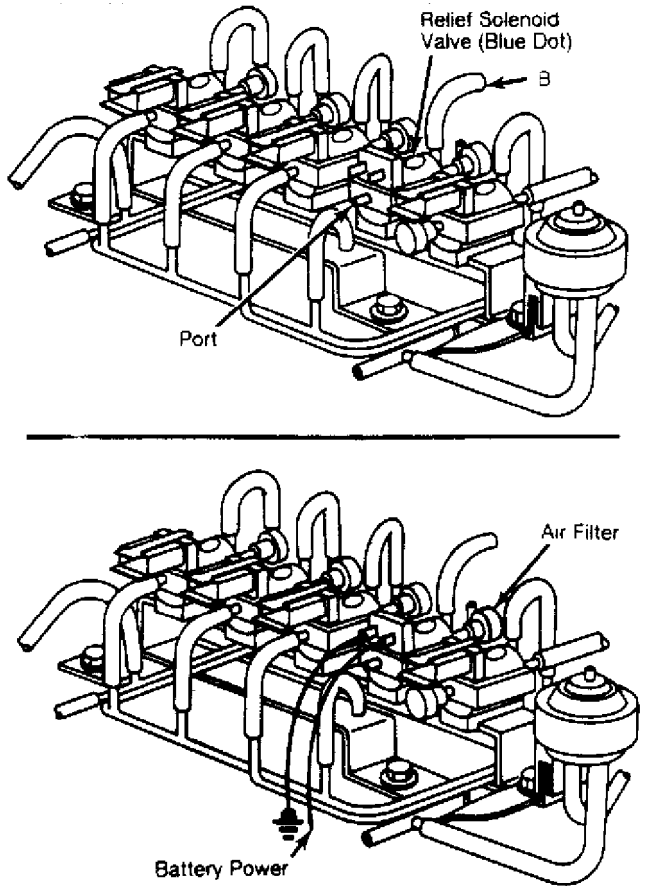
Fig. 3: Testing Relief Solenoid Valve

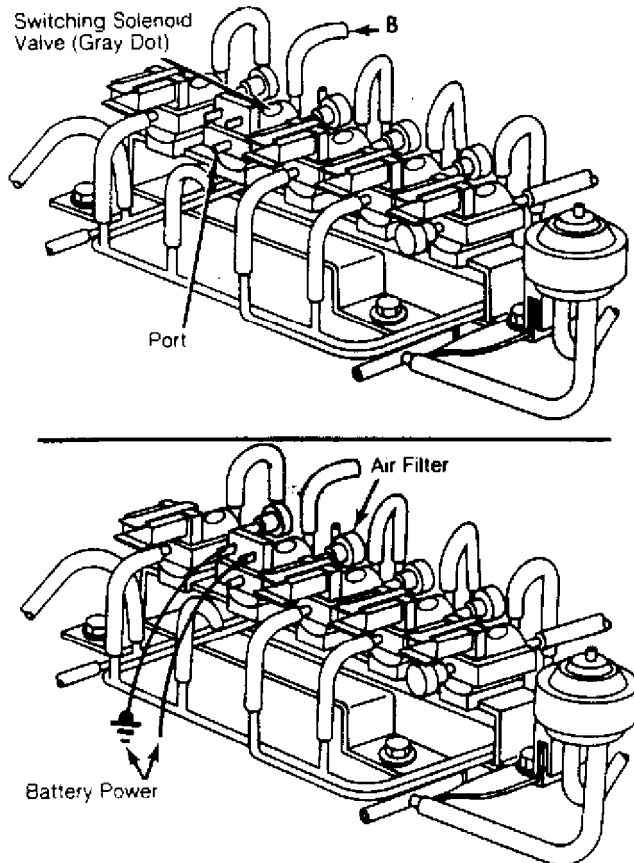
Fig. 5: Testing Switching Solenoid Valve

5) Slowly increase engine speed from idle. Voltmeter should read near 12V at any engine speed. Quickly accelerate engine; there should be NO current flow to switching valve. If switching valve does not respond as outlined, replace switching solenoid valve.

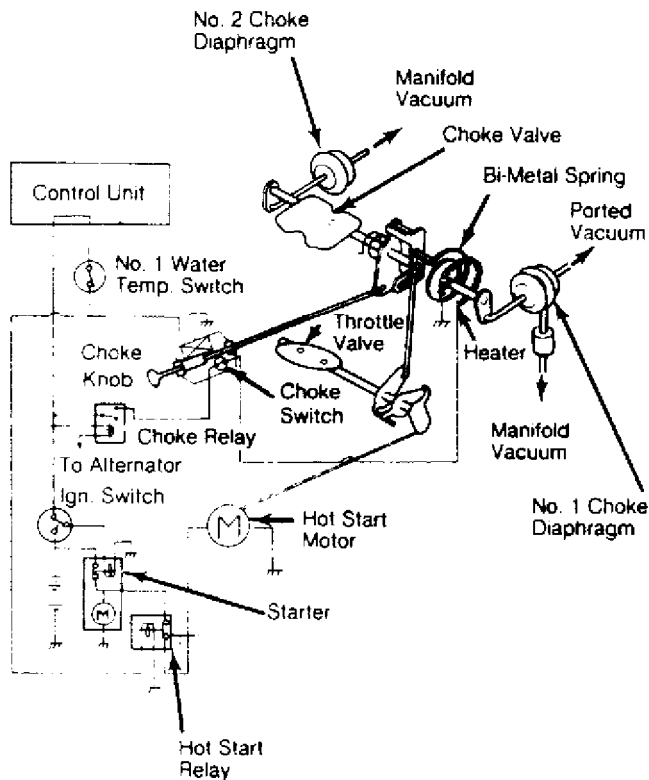
Fig. 1: Choke Return and Hot Start Assist Systems

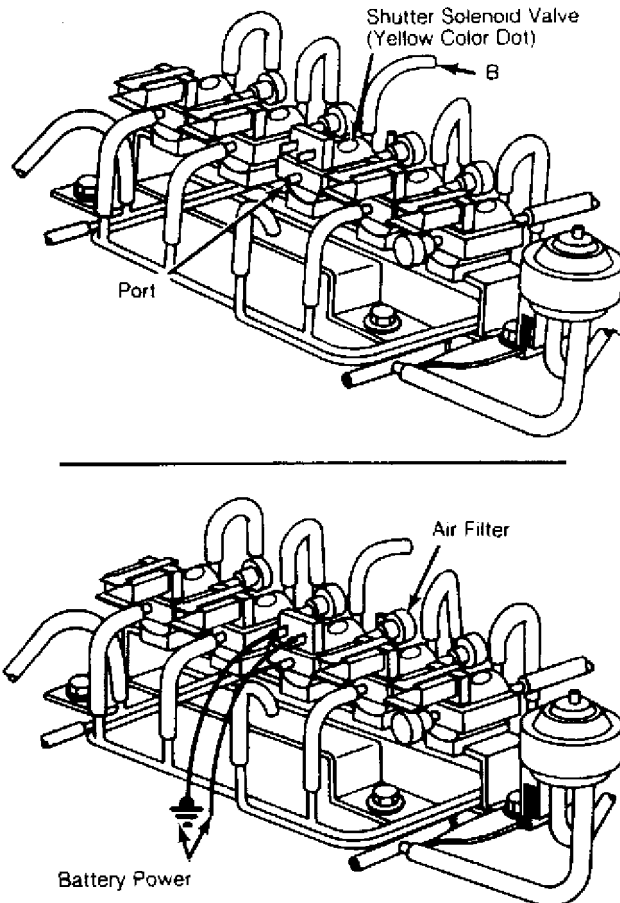
Fig. 3: Testing Shutter Solenoid Valve

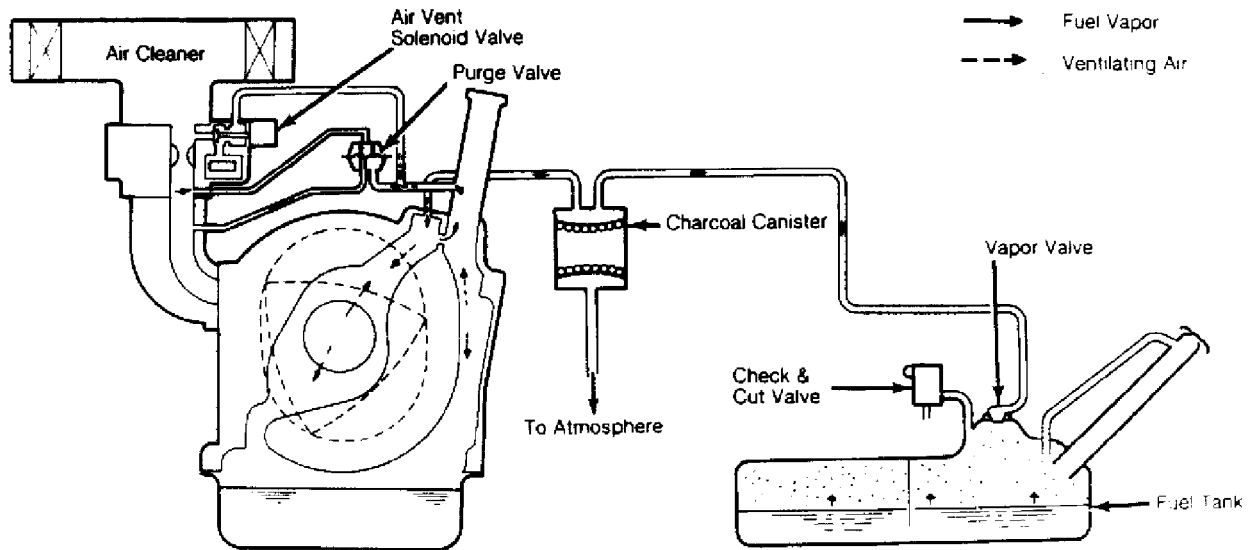
Fig. 2: Mazda RX7 Air Vent and Fuel Evaporation System

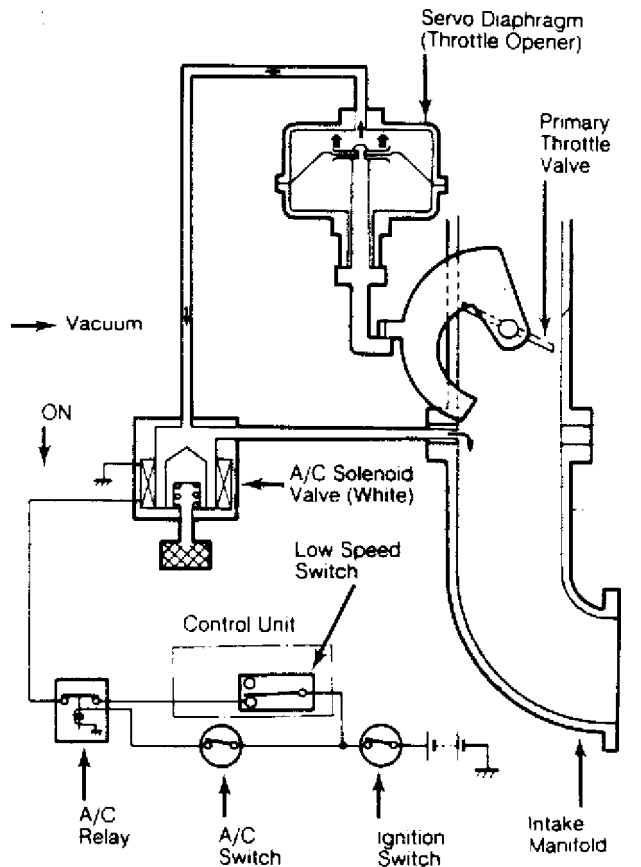
Fig. 3: Throttle Opener

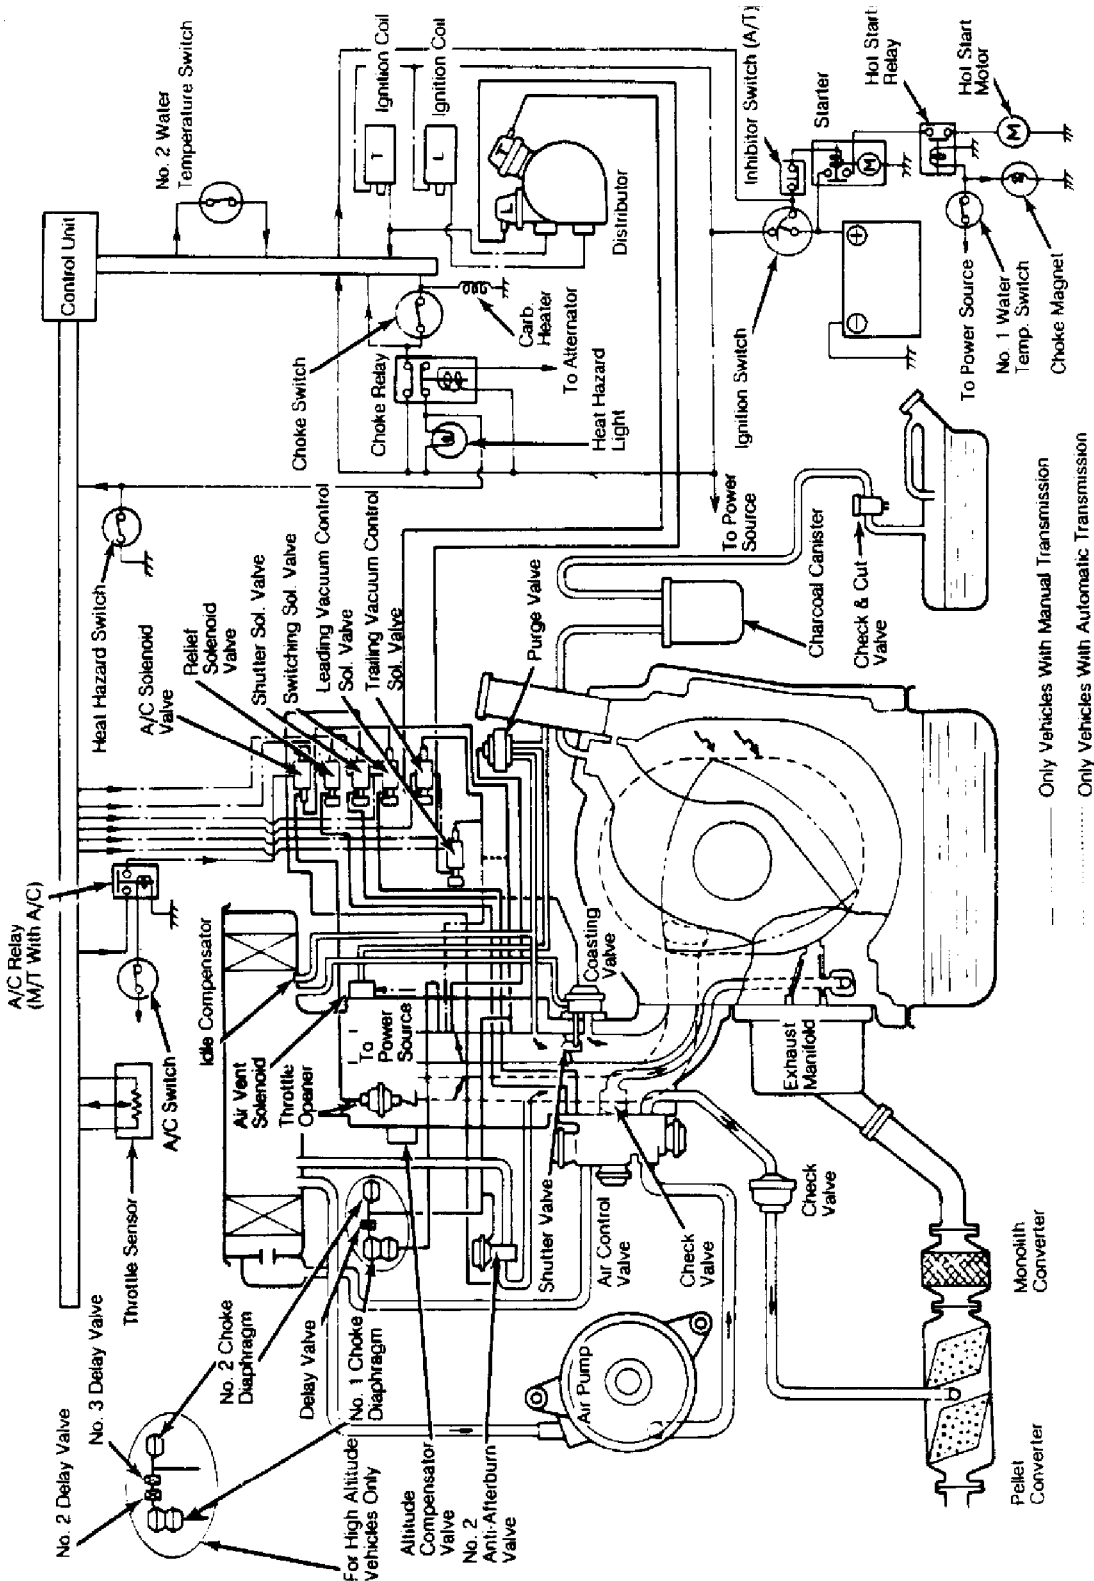
Fig. 1: Mazda RX7 Rotary Engine Vacuum Diagram

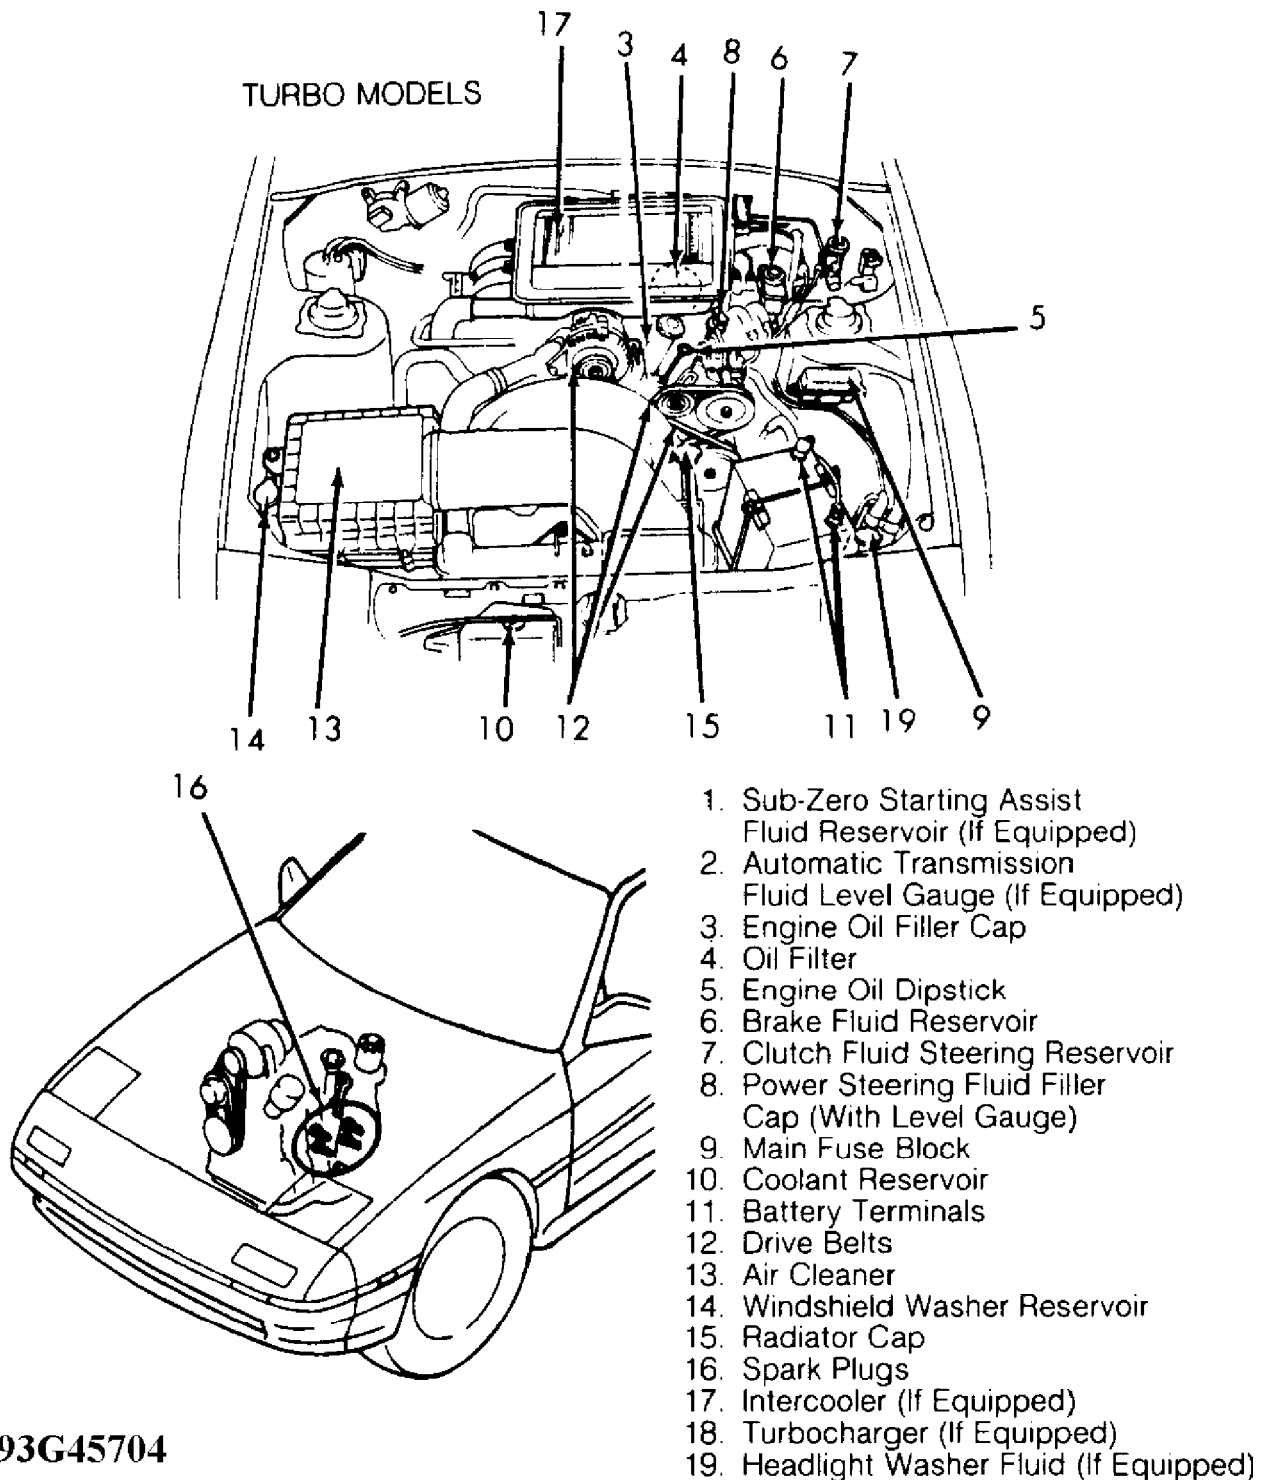
93G45704

Fig. 2: Service Point Locations (Typical Turbo Engine)

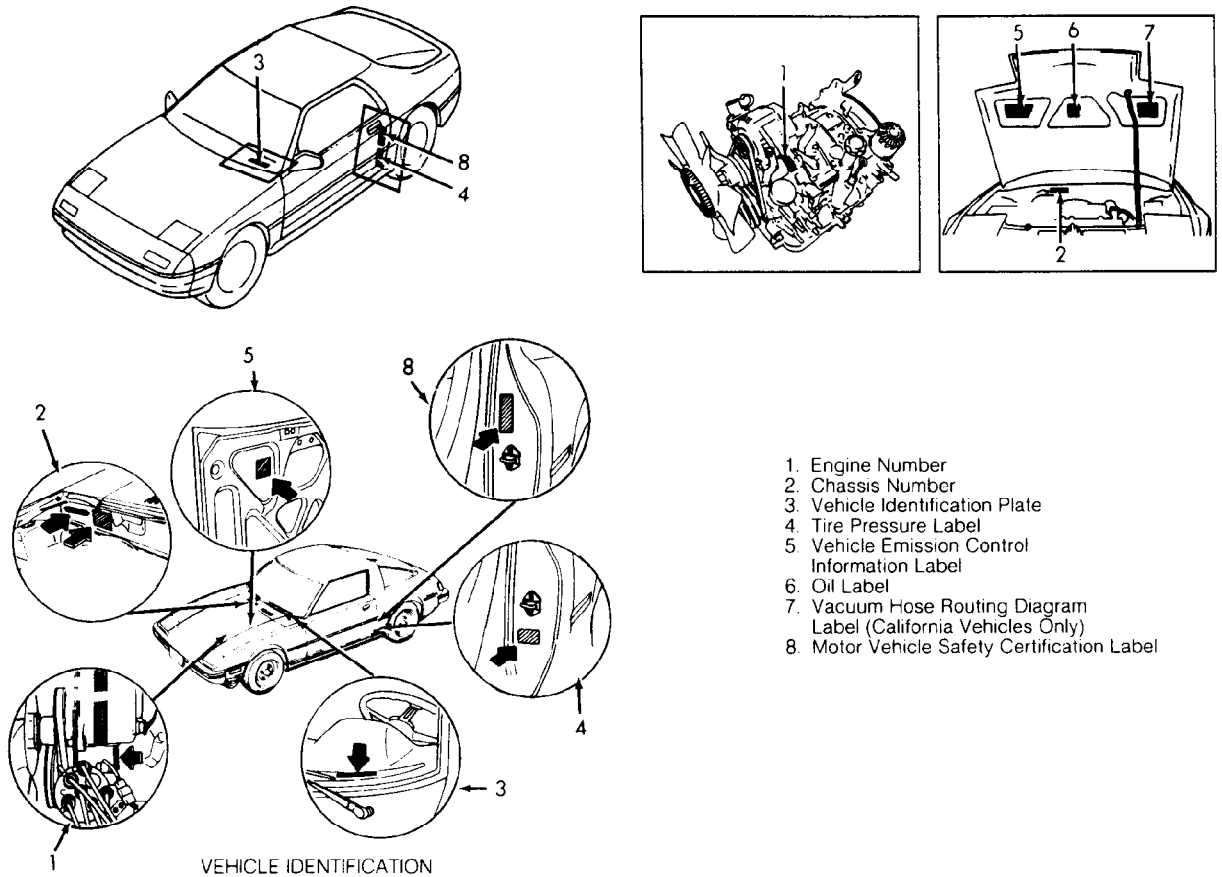
1. Engine Number
2. Chassis Number
3. Vehicle Identification Plate
4. Tire Pressure Label
5. Vehicle Emission Control Information Label
6. Oil Label
7. Vacuum Hose Routing Diagram Label (California Vehicles Only)
8. Motor Vehicle Safety Certification Label

90105054
 Fig. 5: Information Label Locations
 Courtesy of Mazda Motor of America, Inc.

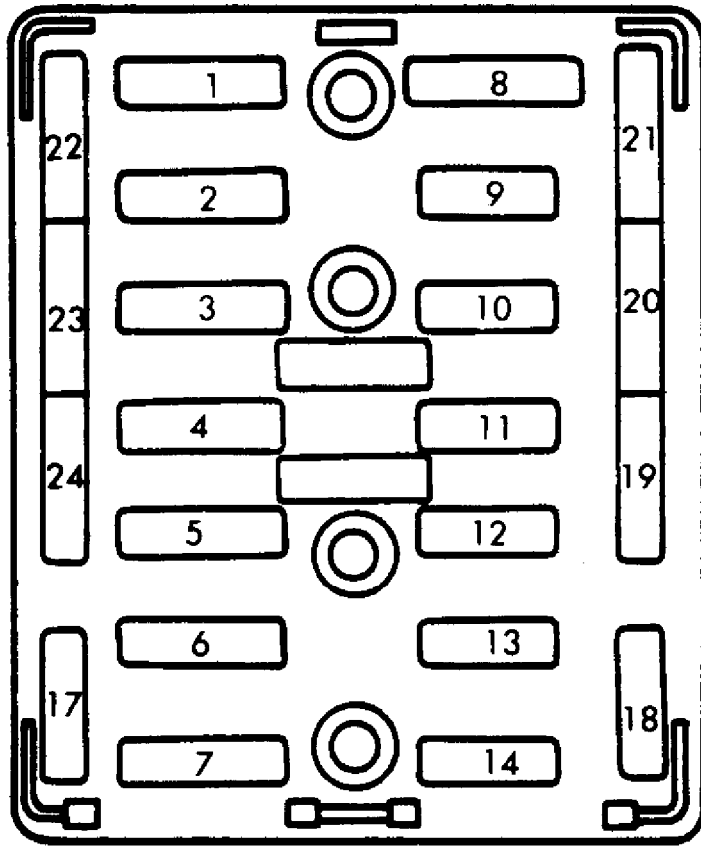
93C45387

Fig. 6: Fuse Panel Identification (1983-85)

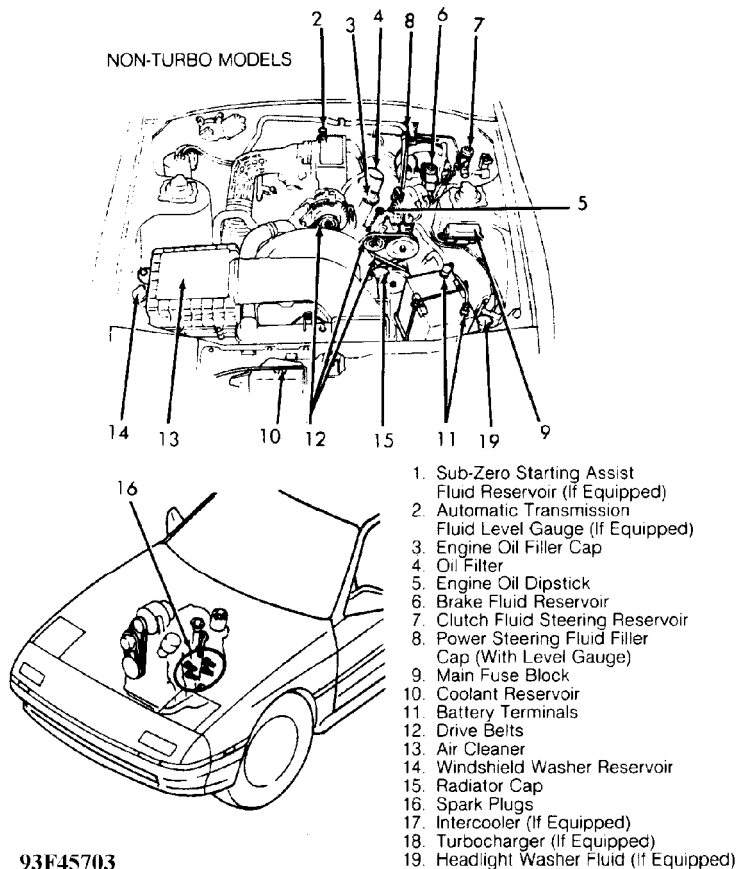
93F45703

Fig. 1: Service Point Locations (Typical Non-Turbo Engine)
Courtesy of Mazda Motor of America, Inc.

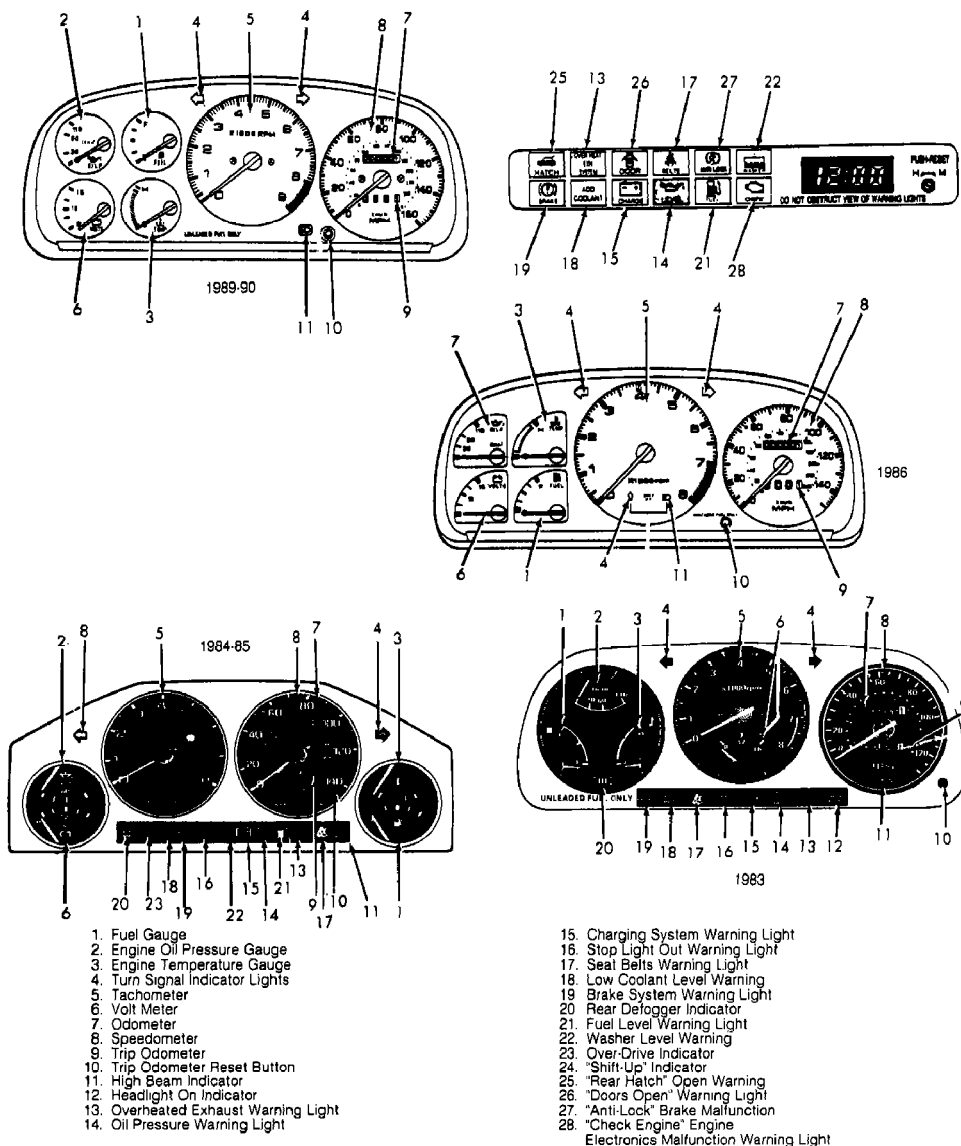
Fig. 1: Dash Gauges & Warning Lights  
 Courtesy of Mazda Motor of America Inc.

The warning lights will come on with the ignition. Any warning light which does not come with the ignition must be checked and repaired.

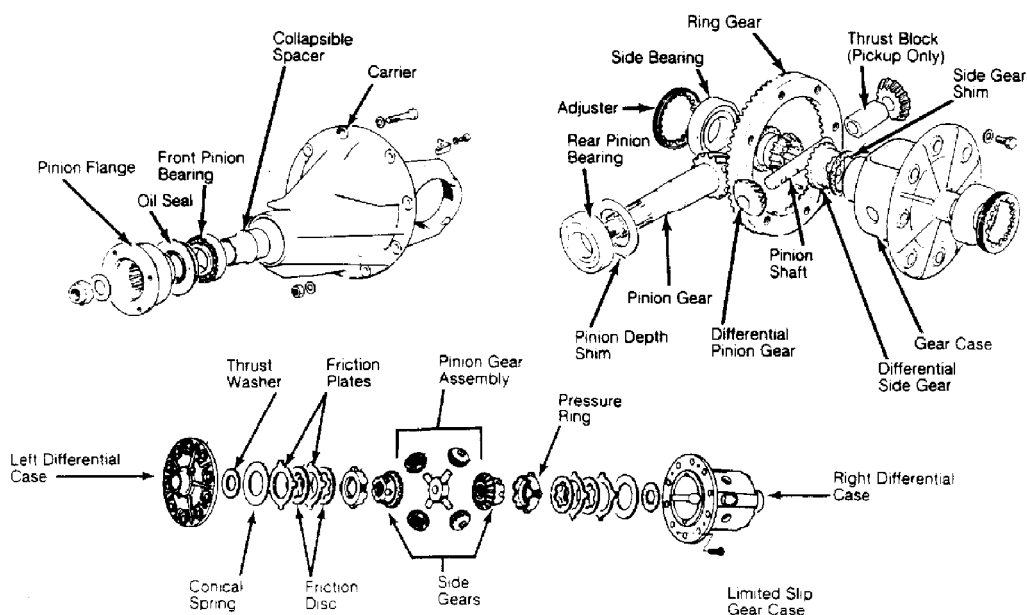
Fig. 1: Exploded View of Mazda Rear Axle Assembly

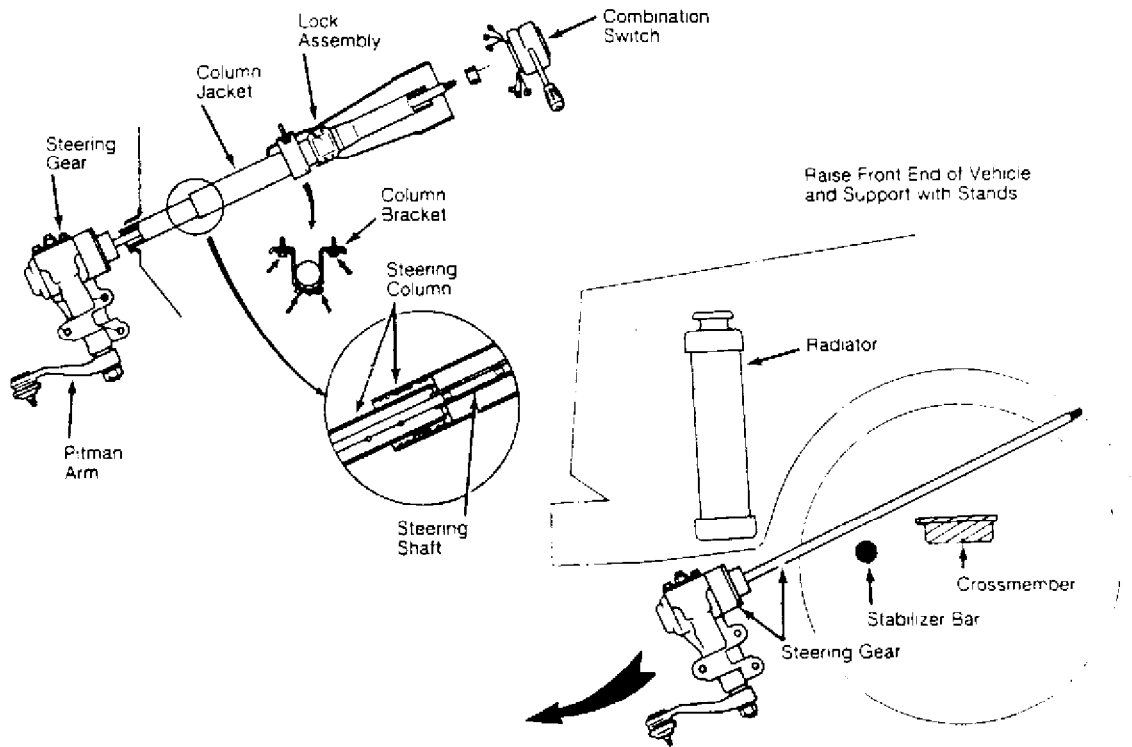
Fig. 1: GLC Wagon Steering Column
RX7 steering column is similar.

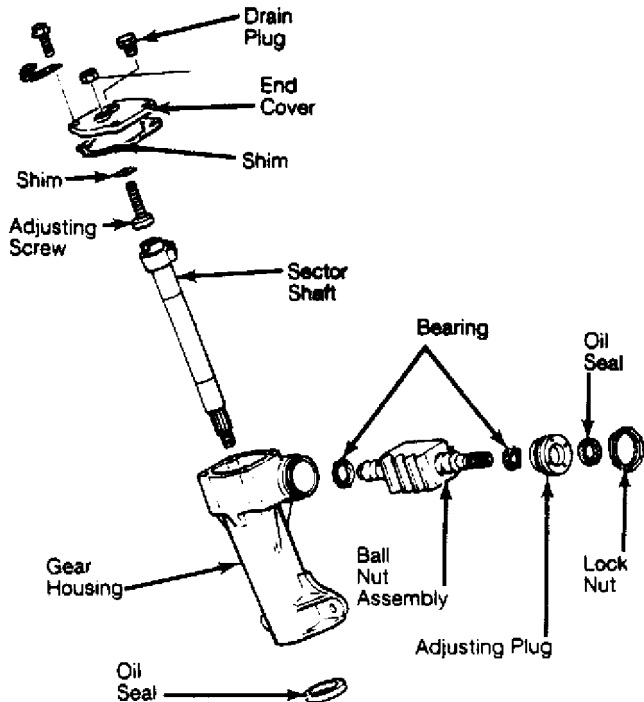
Fig. 1: Exploded View of Steering Gear Assembly (Pickups)

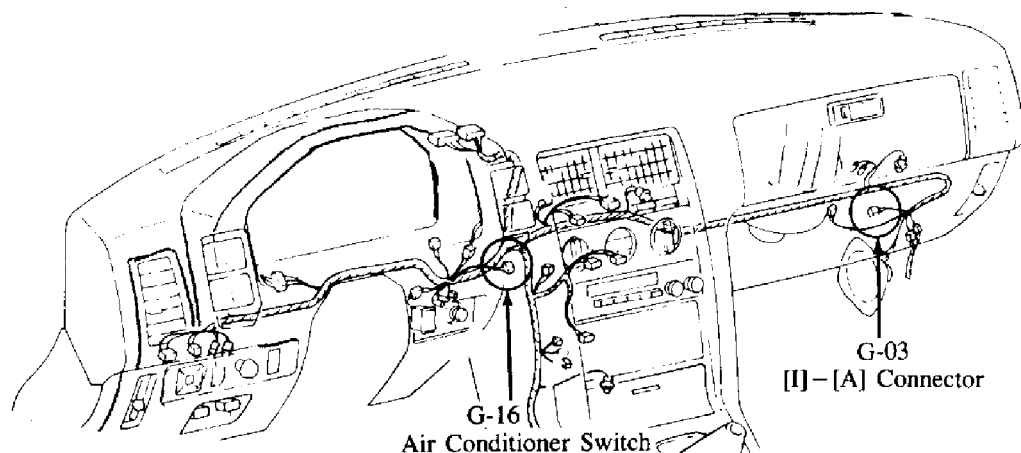
Fig. 1: A/C Indicator Light Harness Routing

Some air conditioner kits manufactured by Lone Star Manufacturing Company may contain incorrectly assembled harness connectors. If the indicator light on the air conditioner switch does not illuminate, or illuminates dimly after installation, the problem may be due to incorrectly assembled G-03 or G-16 connectors. See Fig. 1.

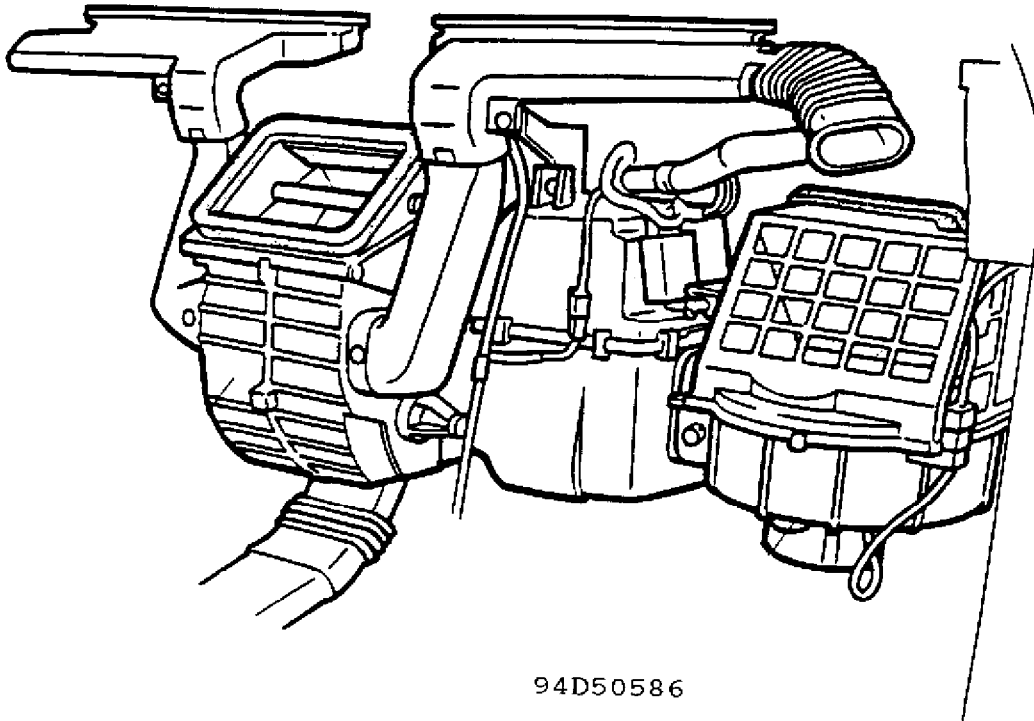
Fig. 1: Climate Control System

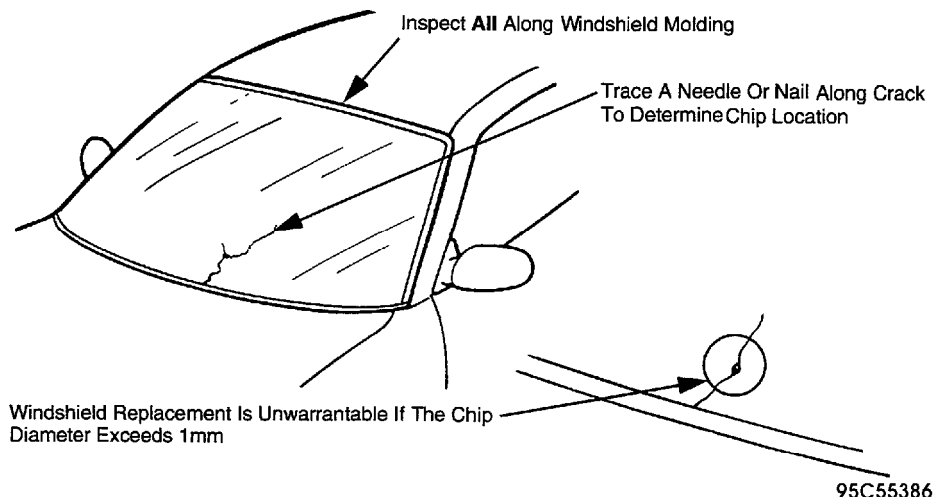
Fig. 1: Windshield Inspection

Windshield replacement is not warrantable if a chip larger than 1 mm in diameter exists along the length of the crack.

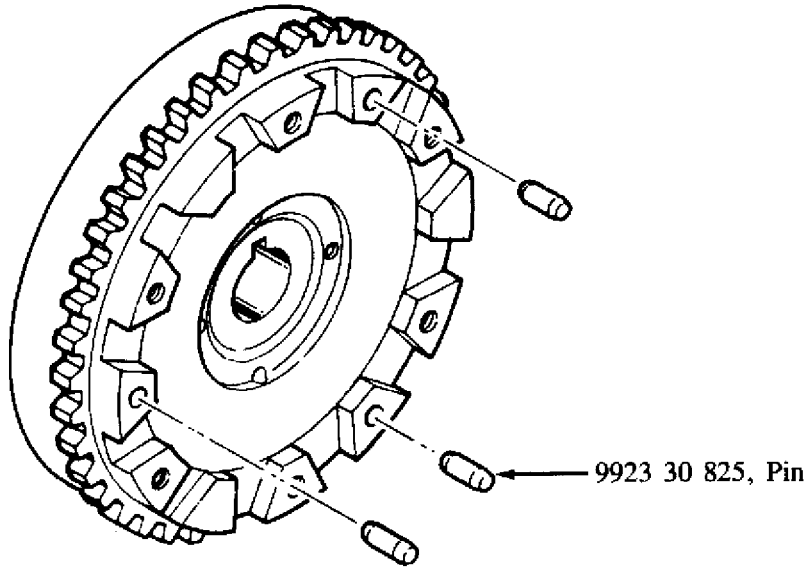
Fig. 1: 83-86 RX7 Flywheel and Alignment Pins

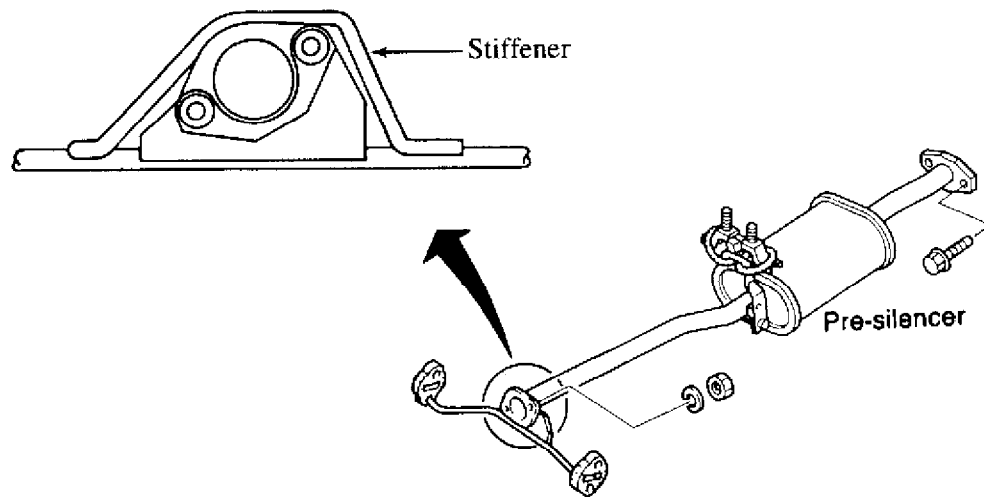
Fig. 1: View of Pre-Silencer with Stiffener

Check the exhaust hanger for breakage. If it is broken, replace the pre-silencer with the modified one which has been reinforced with stiffener as shown in Fig. 1.
