CRUISE CONTROL SYSTEM

1983 Mazda RX7

1983 CRUISE CONTROL SYSTEMS

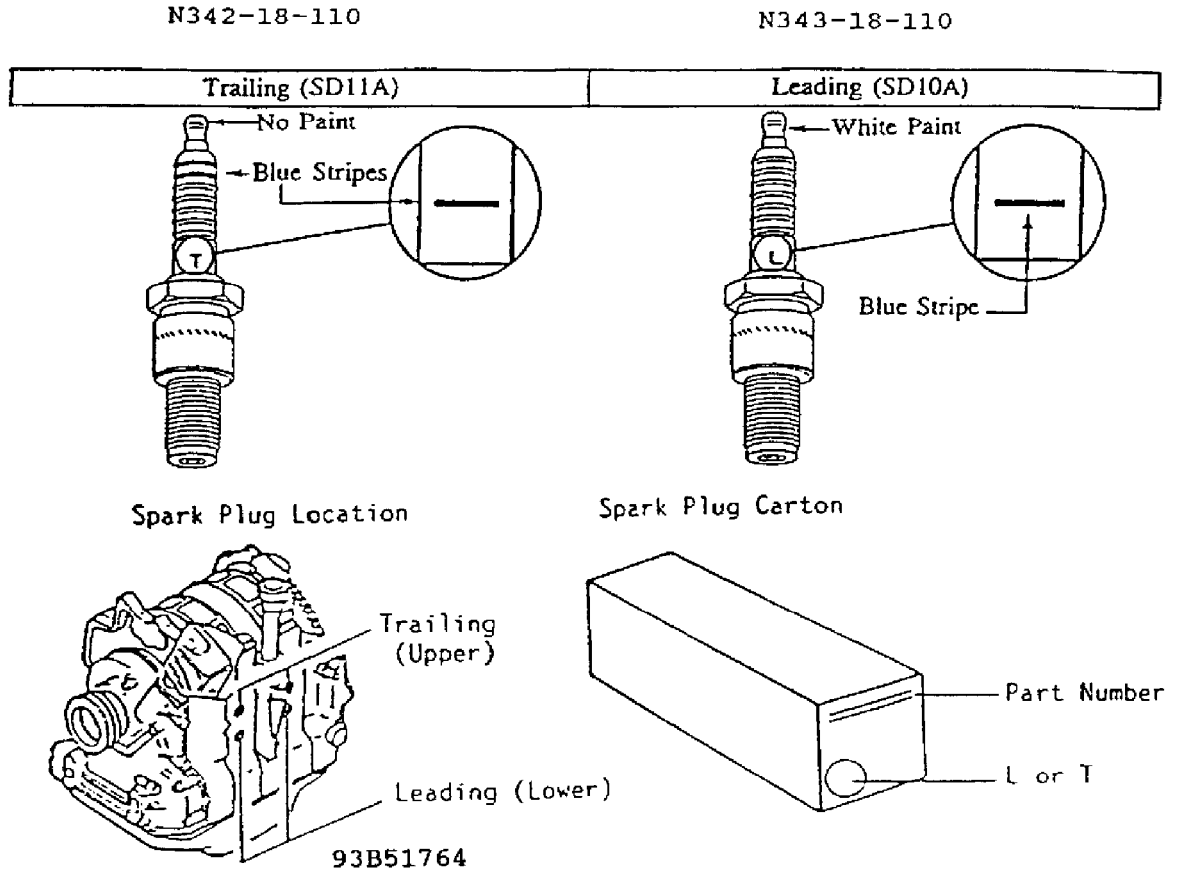
Fig. 1: Spark Plug Identification for 1986-91 RX-7 Engines

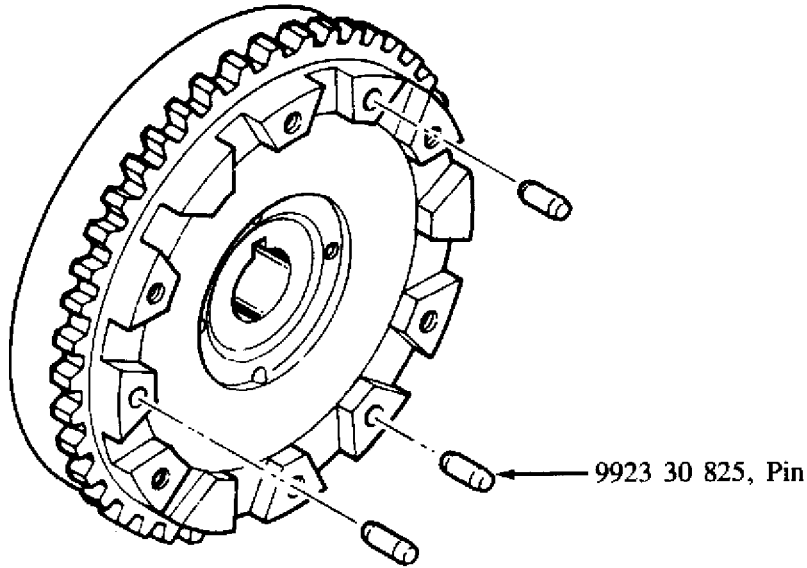
Fig. 1: 83-86 RX7 Flywheel and Alignment Pins

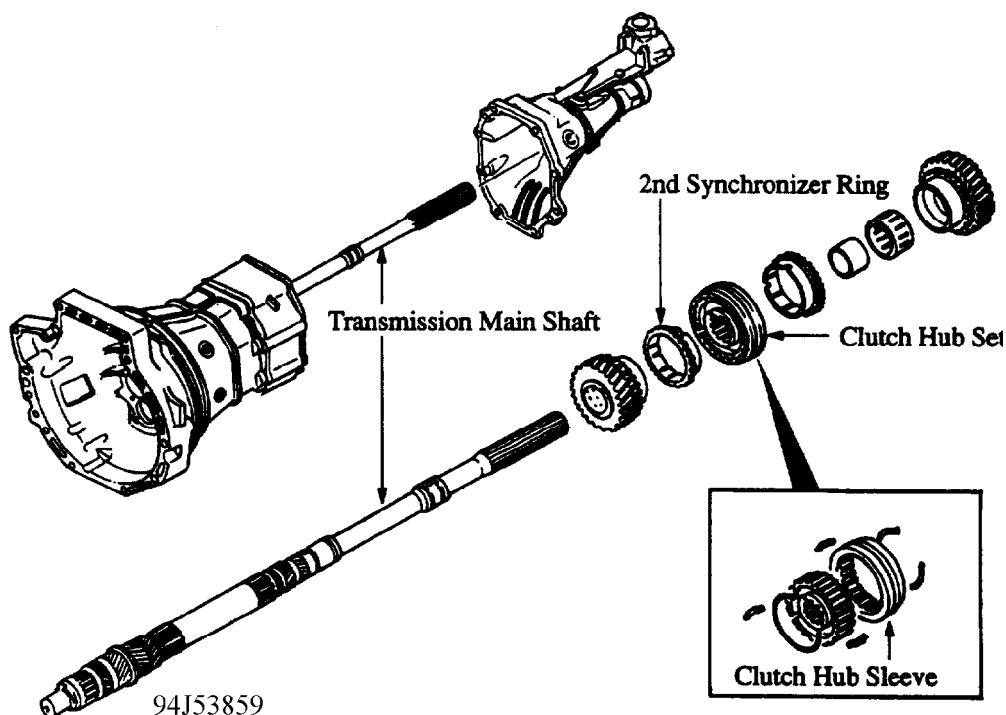
Fig. 1: 2nd Gear Synchronizer Ring and Assembly

If you experience hard shifting into 2nd gear after a cold start with an RX-7 (non-turbo) or Miata produced prior to April 1, 1991, replace the 2nd gear synchronizer ring and 1-2 clutch sleeve (or 1-2 clutch hub set) with redesigned ones. Refer to the appropriate service information for installation procedures.

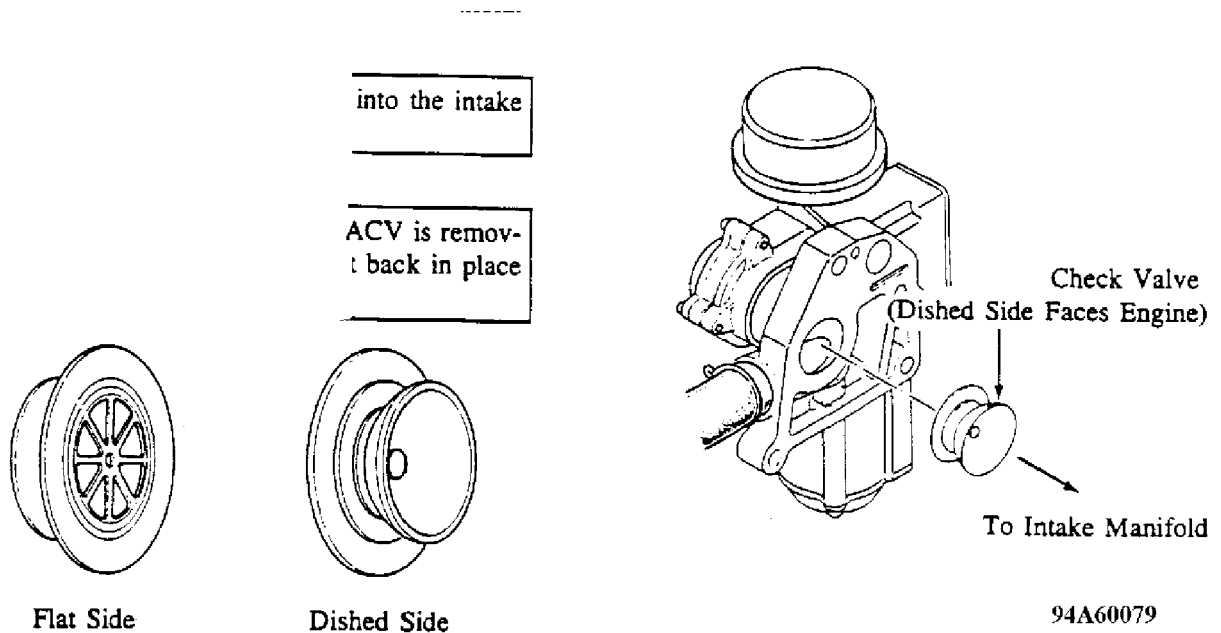
Fig. 13: Check Valve Position and Orientation

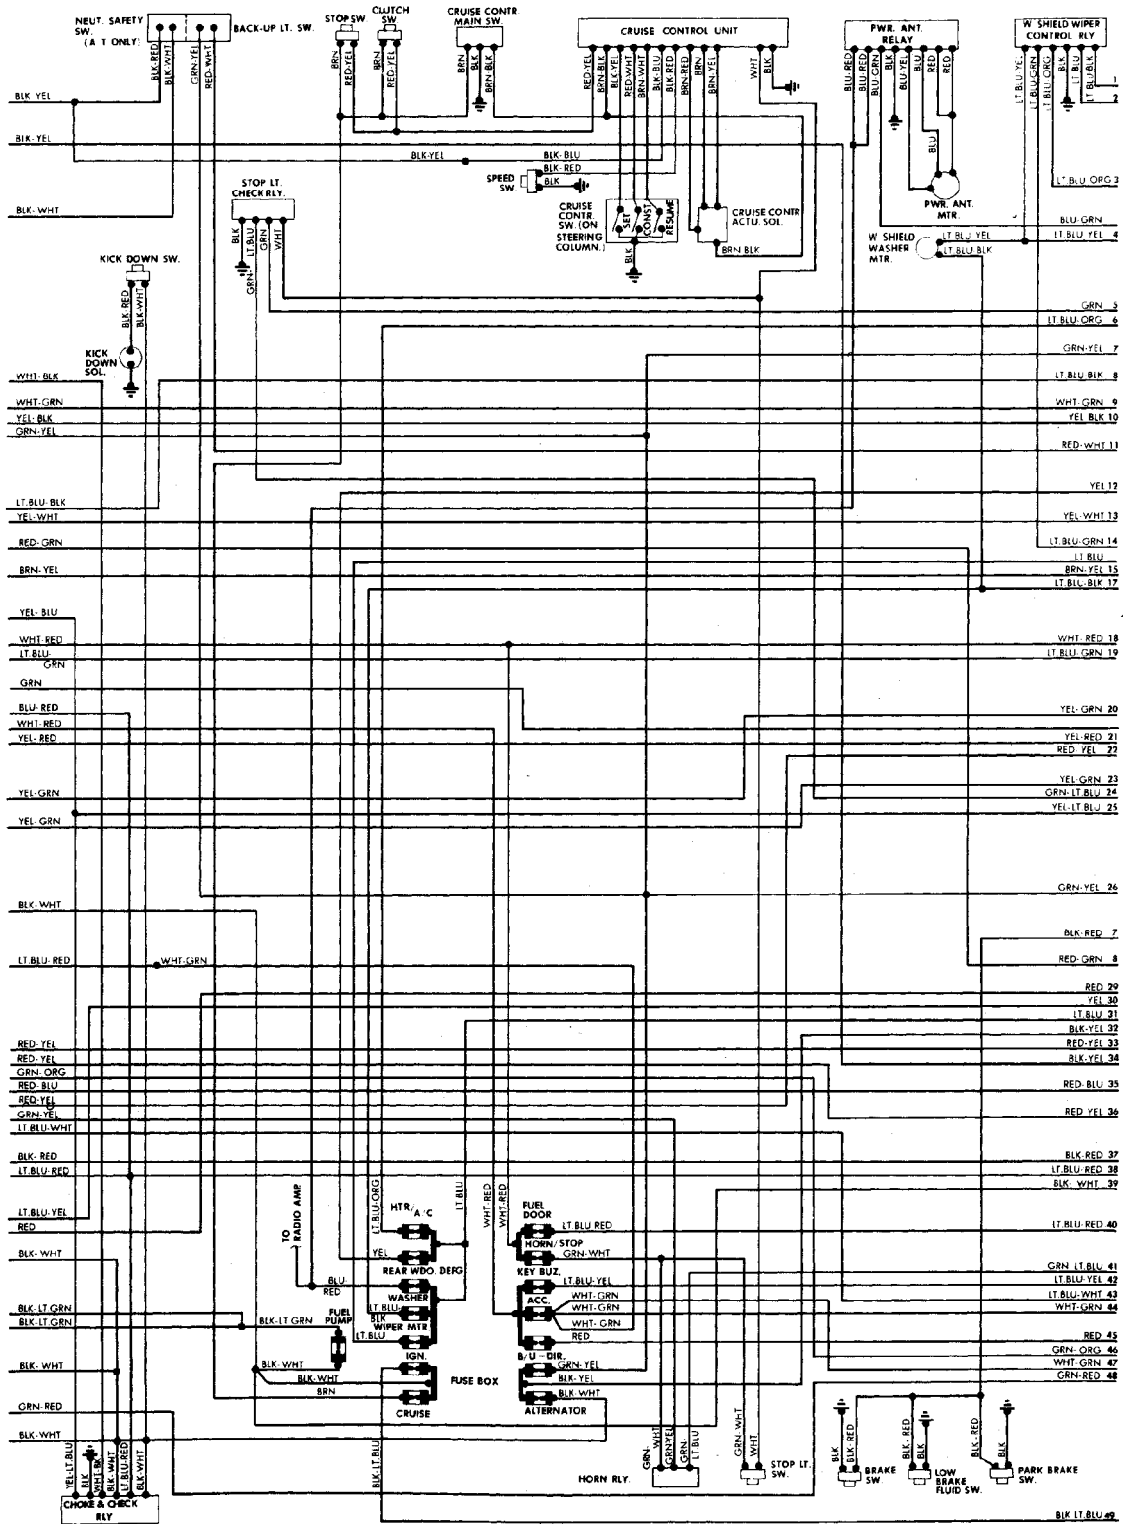
96120
 Fig. 2: Fuse Block & Underdash
